# STS-121/ULF1.1

## FD 05 Execute Package

## MSG 033A - FD05 FLIGHT PLAN REVISION

## MSG 037A (13-0633A) - FD04 MMT SUMMARY

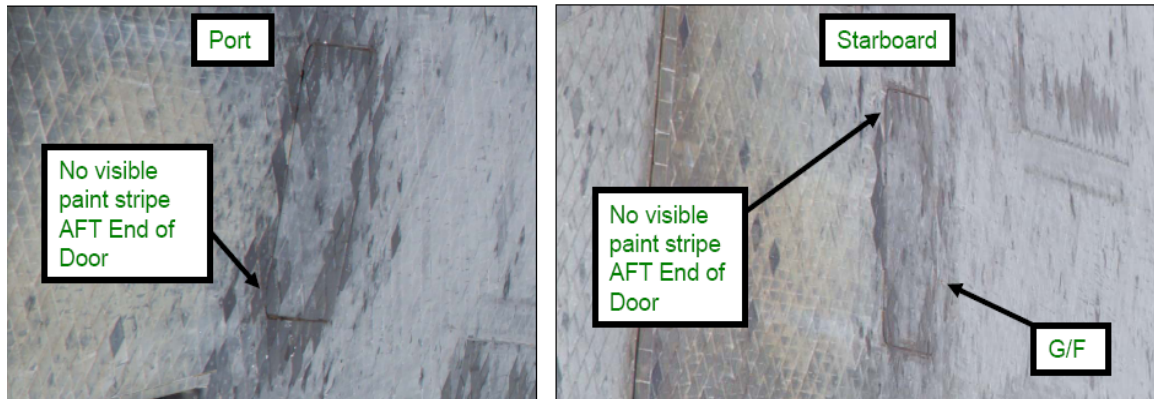
Figure 2 ET Door Imagery

c) ET Doors - The RPM imagery was evaluated and the lighting was determined to be acceptable for paint stripe evaluation. There is no evidence of off nominal thermal barrier protrusions, off-nominal steps, or that any of the paint stripe is visible. The ET Doors are closed, latched, and in a good config for entry (See Figure 2).

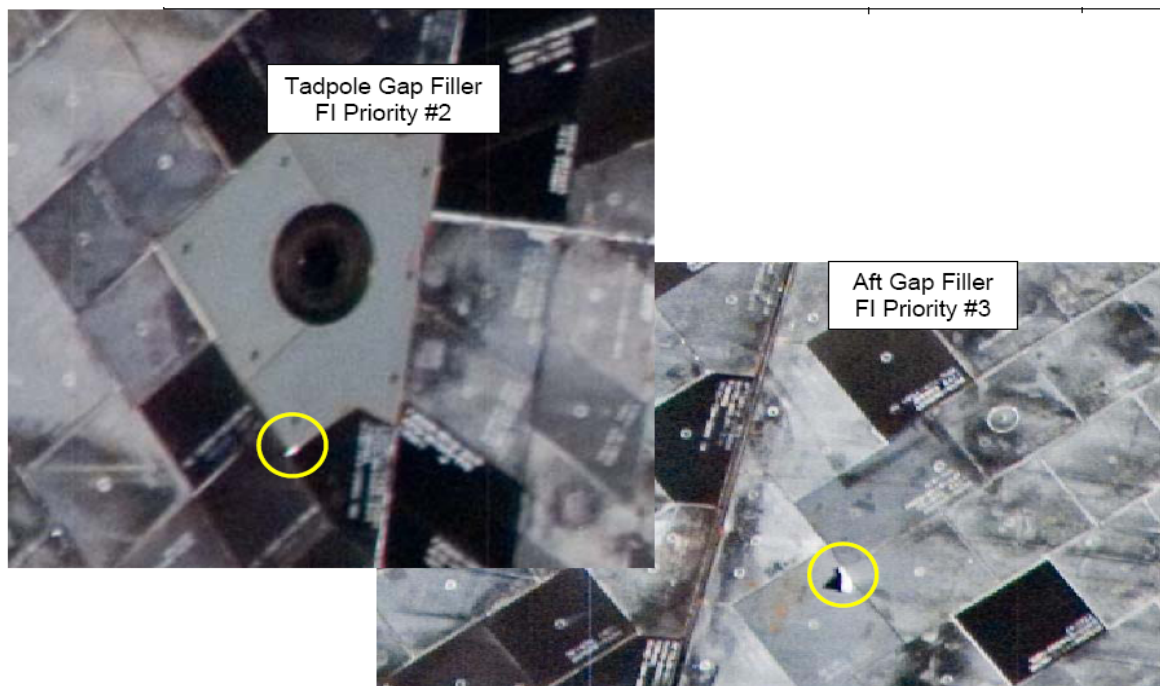
Figure 5 Arrowhead Gap Filler (Left Top) and Gap Filler on Tile Forward of Starboard ET Door (Bottom Right)

10  
11 The remaining two protruding gap fillers at the arrowhead and forward of the starboard ET  
12 umbilical door required FD 4 focused inspections to obtain better height data prior to being  
13 able to clear those areas. Results of analysis on these will be provided to you as soon as  
14 possible. See Figure 5 for view of gap fillers.
